# Debris/Ice/TPS Assessment And Photographic Analysis For Shuttle Mission STS-48

**Gregory N. Katnik**  
NASA/Kennedy Space Center

DEBRIS/ICE/TPS ASSESSMENT  
AND  
PHOTOGRAPHIC ANALYSIS  
OF  
SHUTTLE MISSION STS-48

September 12, 1991

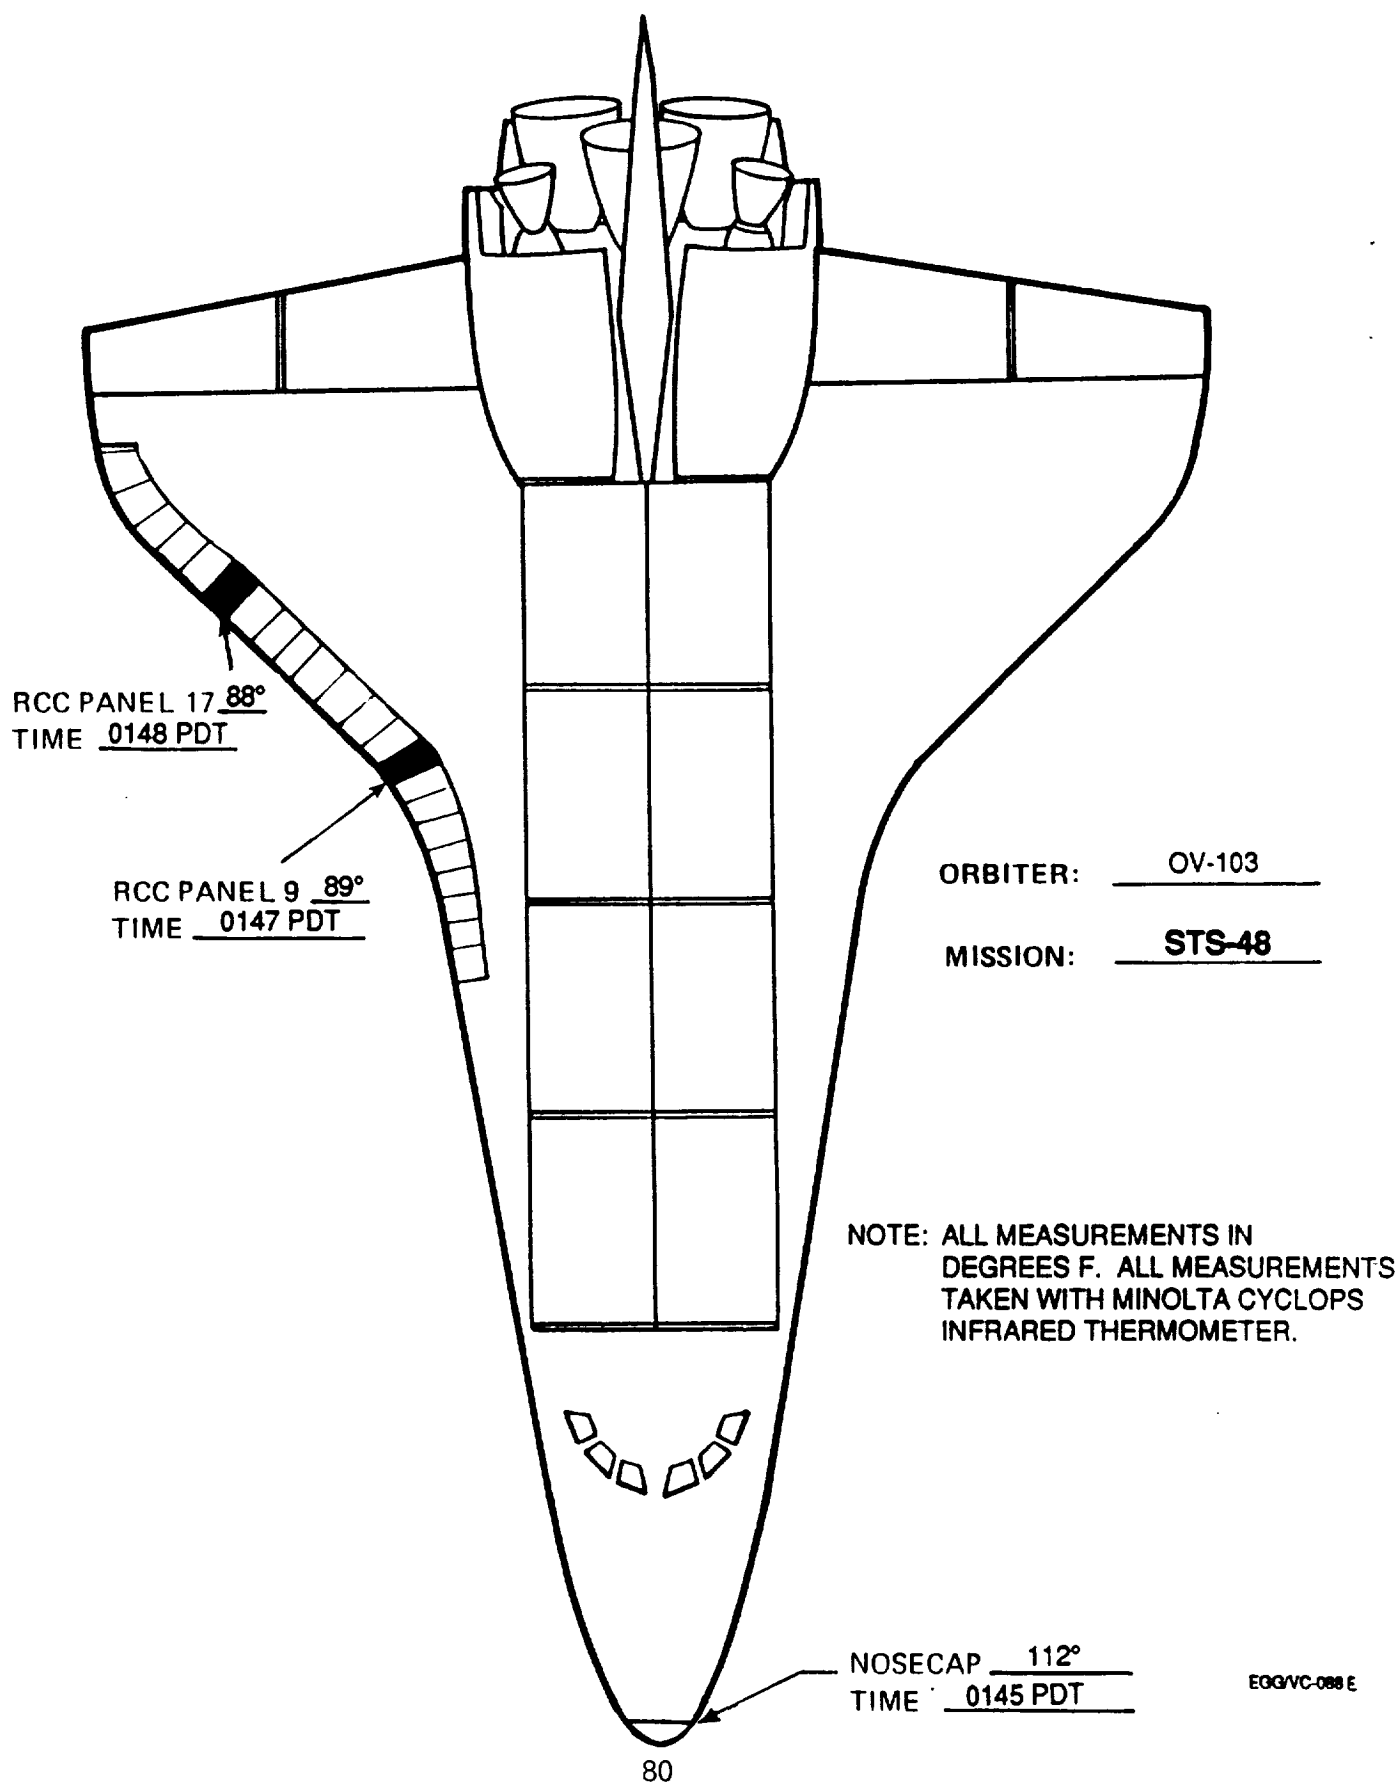
FIGURE 16. **STS-48 RCC TEMPERATURE MEASUREMENTS**

A portable infrared thermometer was used to measure the surface temperatures of three areas on the Orbiter TPS after landing (OMRSD V09AJ0.095). Seventy minutes after wheel stop, the Orbiter nose cap RCC was 112 degrees F, the RH wing leading edge RCC panel #9 was 89 degrees F, and the RH wing leading edge RCC panel #17 was 88 degrees Fahrenheit (reference Figure 16).
